Manhole Inspection Summary

Manhole # S27K__026MH

Insp Date: **3/26/09 12:55 PM**

Location Address: **RYAN ST**

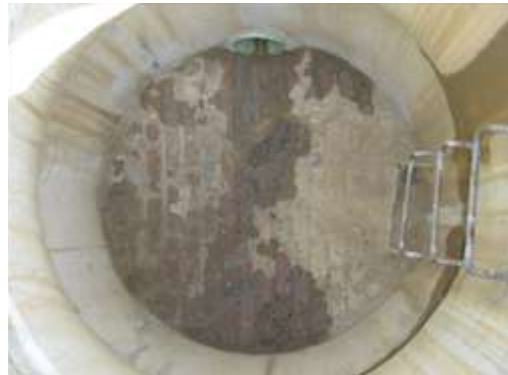
Top View

2 inch Offset visible in top view photo

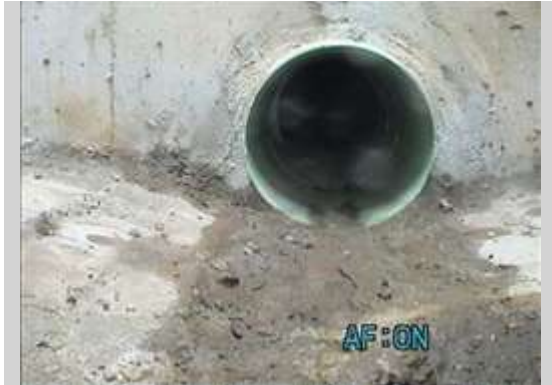
12 O'Clock Outflow

8 in. Circular Gravity Sewer
Pipe Out @ 12 O'Clock

Pipe Height: **8.4** (in.) Rod and Bar (Angled)

Pipe Material: **Clay** ☐ Pipe Lined

Infiltration: **None** Pipe Seal Cond: **Sound**
